STREAM MORPHOLOGY I: BRASS GRANT PROJECT

This is the first of a 3-part series. BRASS thanks the Lake Champlain Basin Program, the NYS Soil & Water Conservation Committee, and Trout Unlimited for funds that enabled BRASS to carry on this project.

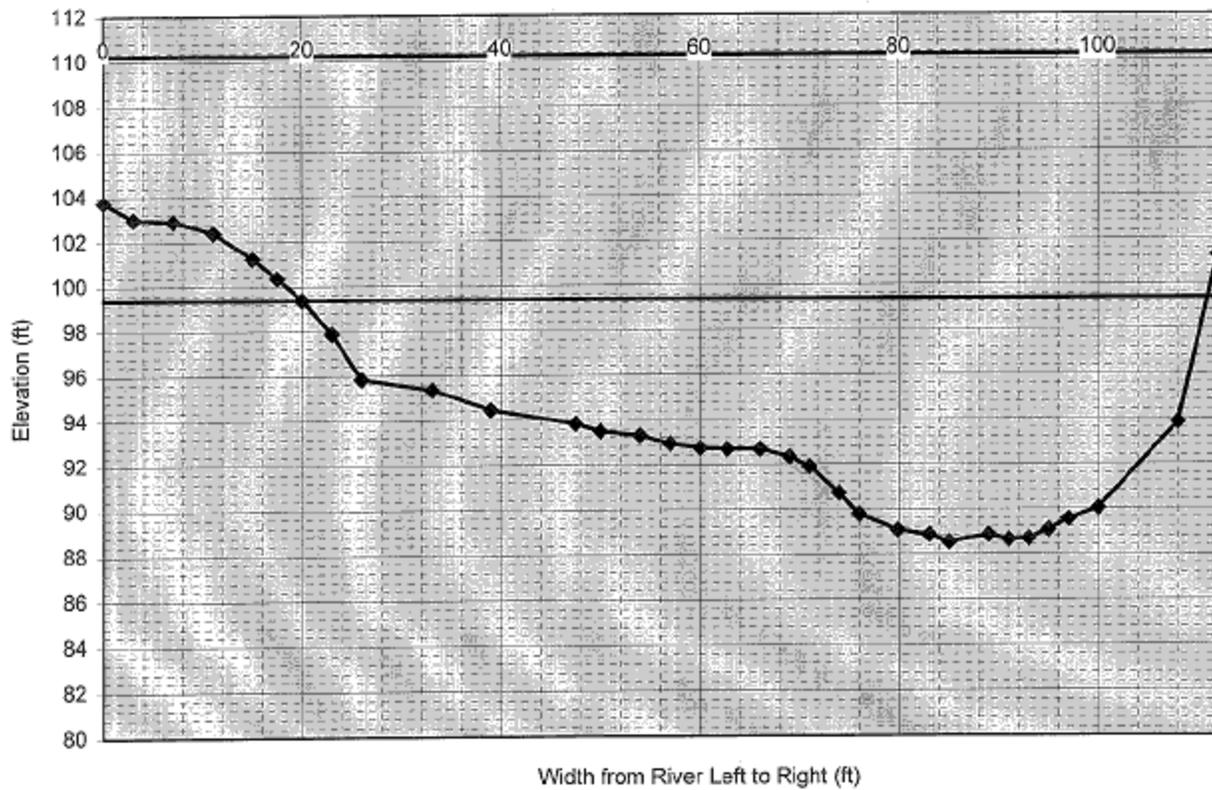
Look at the cross section graph. It represents a slice across the river downstream of the house at the meander bend. You can see how the bed deepens at the outside right (eastern) bend. The house sits upstream and to the left. The dotted line is the channel outline; dots are elevations read with a laser level and stadia rod. The bottom horizontal line is the "bankfull" elevation, where the water level will be every 1.5 years on average. The top horizontal line represents the elevation of the 50-year flood which is nearly 6 feet above the base of the house and top-of-bank.

The survey has given us clues about how to proceed with erosion control, and what warning to give the landowners. The house needs to be moved or elevated to protect occupants from future floods. The width to depth ratio and gradient are within appropriate ranges for a stable "C" stream. Being hindered from developing its normal meander pattern by the railroad bed, the channel will continue to aggrade. Without roughness, the energy of the river will continue to cause bank erosion in susceptible areas. Vegetation along the bank by the house is absolutely necessary, and it appears it will have more chance at successful growth if the current steep embankment is shaped to permit a break in slope at "bankfull" and a more gradual incline to the top of the bank.

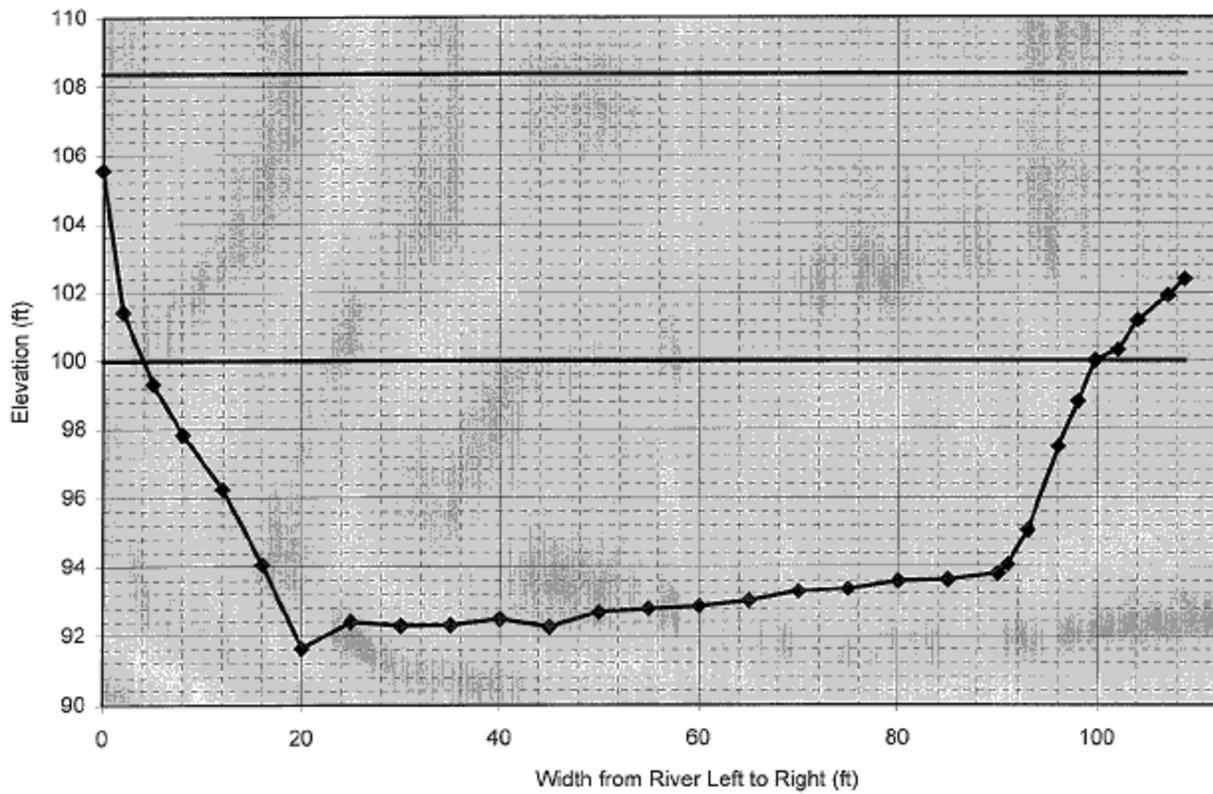
This is a cross section of an area about 350 feet upstream of the house. Here you see the trapezoidal channel bed.

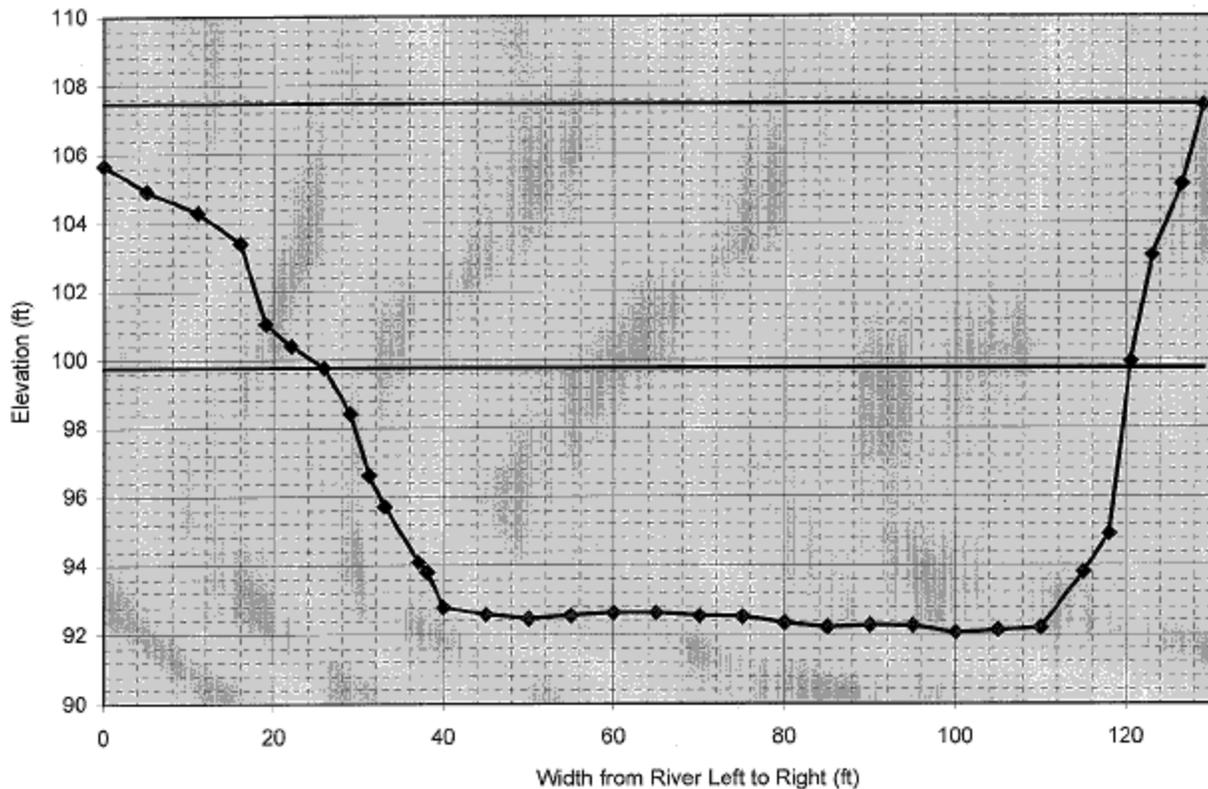
In another cross section, about 400 additional feet from the one shown above, once again the channel bottom looks like a trapezoid, but look at the left bank.

Notice the change of slope at the "bankfull" mark. This keeps the bank from being so steep, even though it is the same height as the left bank in the second cross-section (almost 14 feet from the bottom of the channel to the top of the bank). Not surprising, there is lush bush vegetation along the left bank with vigorous root growth helping to add roughness against the water's energy and to hold bank soils together. There is no sign of erosion along the left bank for about 400 feet upstream, and upstream cross sections continue to show the same break in slope at the "bankfull" mark.
