STREAM MORPHOLOGY II: BRASS GRANT PROJECT

Wadhams, Downstream of Ox Bows

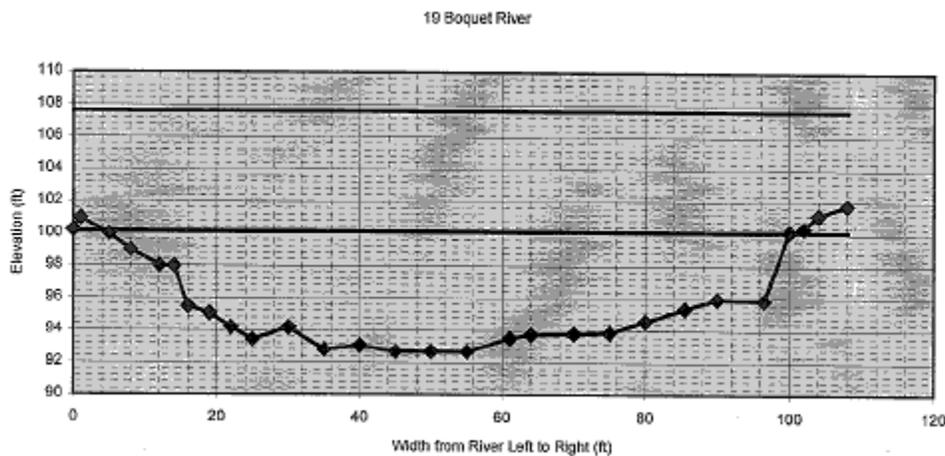
The river on this section has good access to its floodplain, allowing it to move back and forth when needed and lessening its power during flood stage to do damage. This is called the "entrenchment ratio." Our section exhibits a 6 to 1 ratio when the flood prone width is divided by the bankfull width. (To determine flood prone width, which approximates a 50-year flood, you double the height of the river when at bankfull stage.) In the cross-section diagram of the river, you can see the contour of the channel's bed and banks by the dotted line. Each dot represents a surveyed point; each light horizontal line represents a foot in elevation.

The dark horizontal between the 100 and 102 instrument elevation is the bankfull line. The dark horizontal line at about the 108 elevation is the 50-year flood prone level. You can see it is well above the top of both banks by about 6 feet.

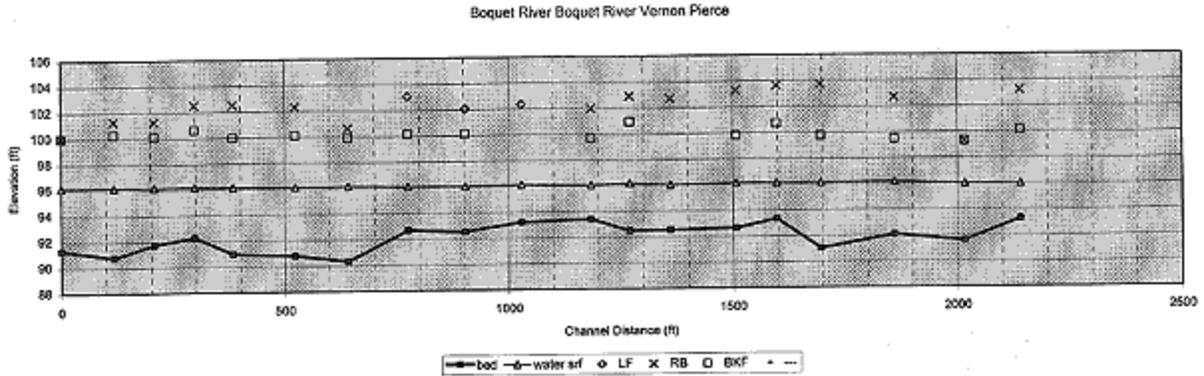
This section has an average sinuosity of 1.4, meaning the length of the wiggling river is 40% longer than a straight line down the valley from the beginning point of the survey to the downstream end. The bottom bed of the river, even though it consists primarily of medium sand, varies in contour as if it had shallow riffles and deep pools. (See the cross-section diagram of the river's length.)
