# STREAM MORPHOLOGY III BRASS GRANT PROJECT

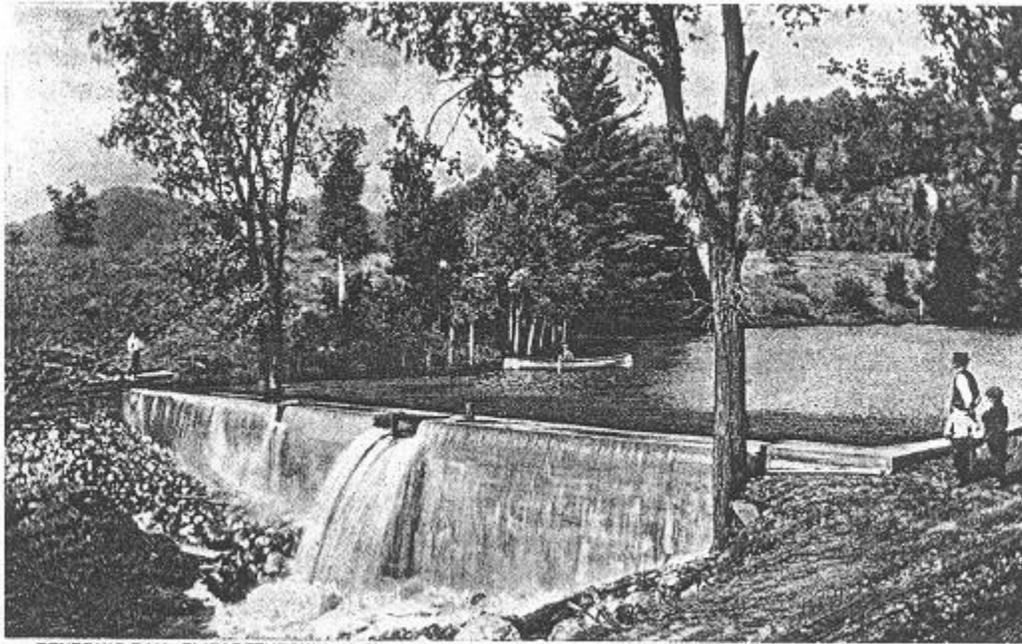
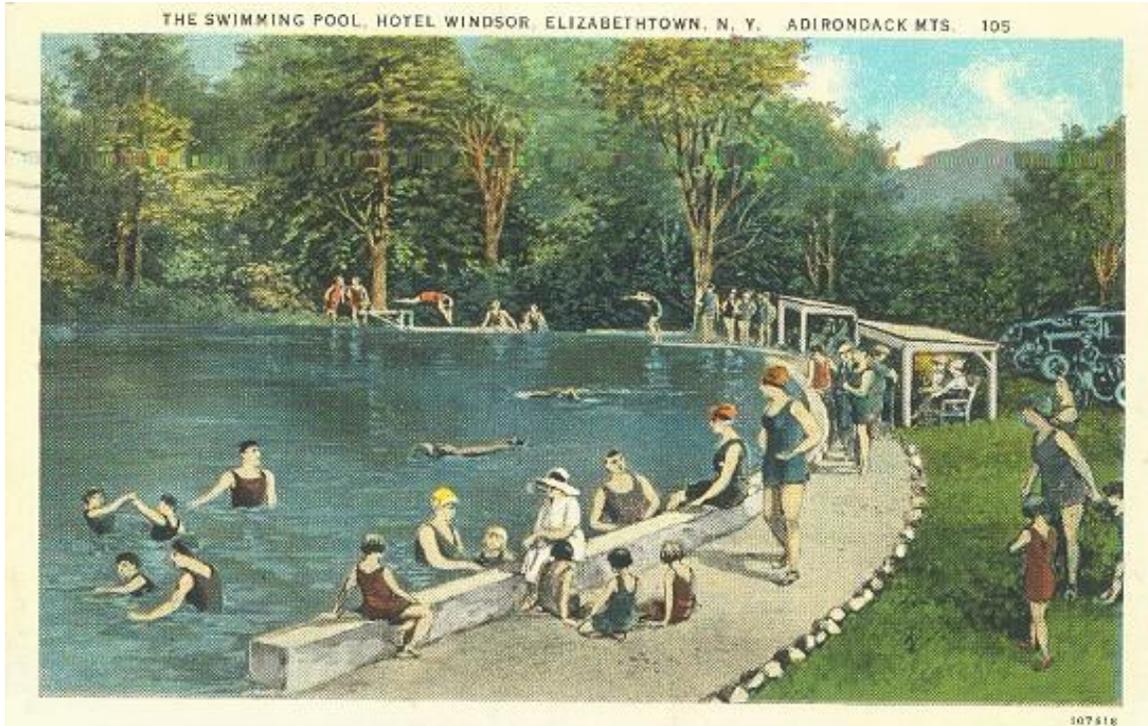
The brook has riffles, runs, pools and glides. Although the channel bed is predominately gravel, there are large cobbles and even a few boulders in riffle

areas. When we conducted 50-year flood measurements, all houses, driveways, and buildings were above the flood mark except for the base of a small roofed bridge over the brook and a small shed. Channel stability assessment showed some stress, including exposed tree roots, siltation of some pool areas, and growing mid-channel bars.
