## ***NEW RUSSIA CRIB WORK***

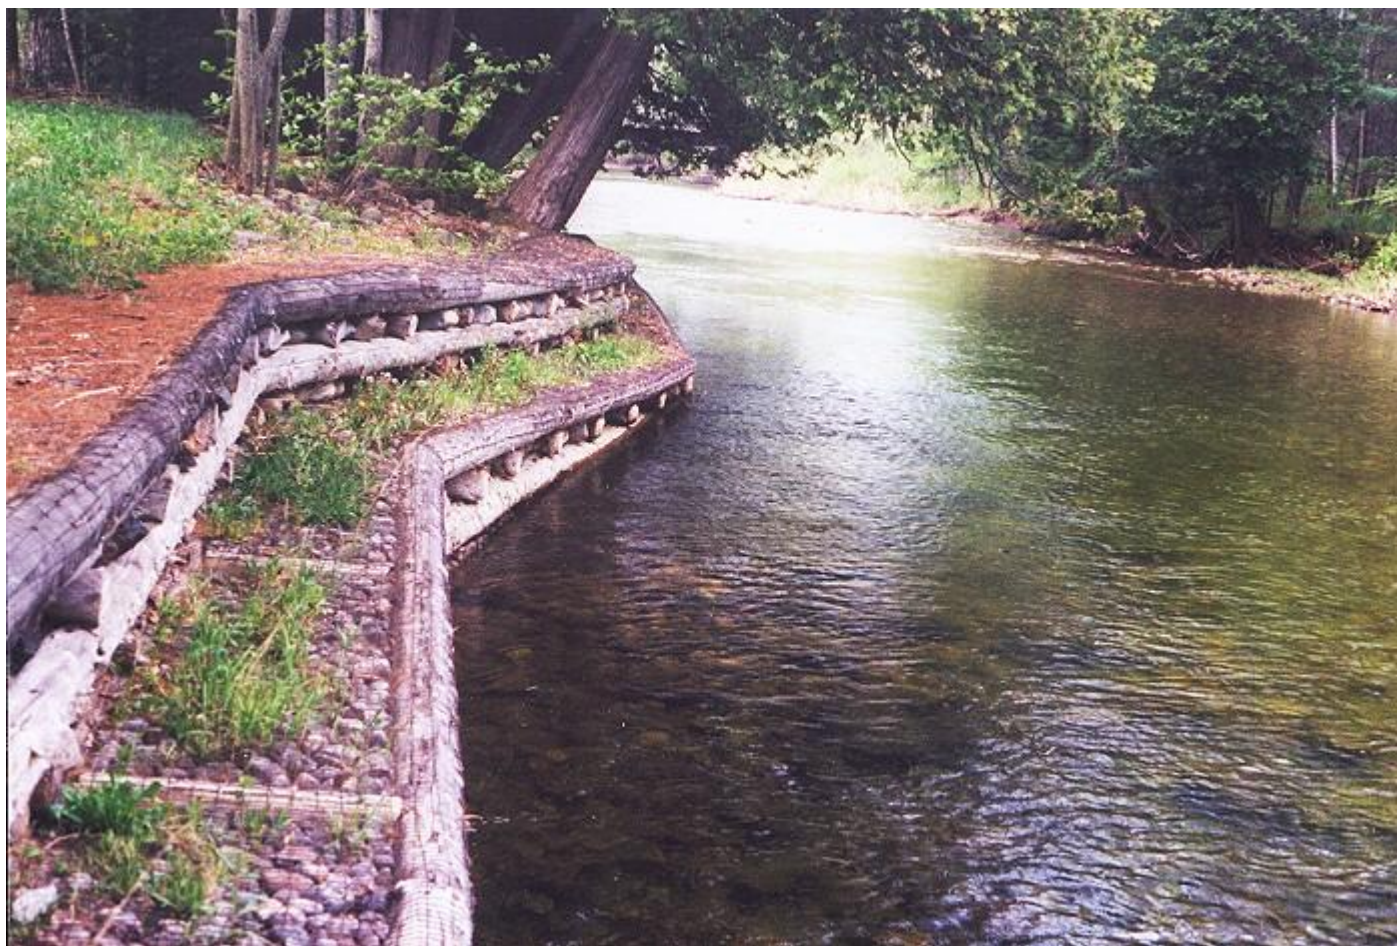
The resulting structure was beautiful and practical. But sometime during the winter of 2001-2003 a two-foot slump appeared in the mid section of the crib. A worried landowner pleaded for assistance, not finding anyone willing to design and fix the problem slump. With Moriah Shock willing to send a crew and John Northup back to the site, BRASS agreed to submit a design and permit to the agencies and coordinate the repair if the owner again picked up the equipment and material costs.

We assumed the front base log--or a section of the cedar pole flooring--had broken, and were prepared to employ hydraulic jacks to replace any logs, poles or cross ties. To our surprise, the slump was due to undermining of that section. Had we performed longitudinal and cross-section surveys of this river reach in 1992 (a task we didn't know how to do at the time, nor did we own the necessary equipment), we would be eager to show you the difference in the channel geometry over a 10-year period of time. Depth of water at the face of the crib when it was built in 1993 was only ankle to shin deep; this fall water could easily enter chest waders if someone was silly enough to bend over. (There were several silly and surprised people.) The thalweg, the deepest part of the channel, had moved over about 25 feet.

What would make the river move that much? Rivers can and must move around to efficiently carry their water and sediment load. But we suspect the river had some help. Several major floods occurred in the next two years after the crib was built, and Route 9 was flooded in several locations immediately upstream. After-flood response by the Department of Transportation included the removal from the river of a large collection of gravel which was errantly piled on top of point bars on the inside bends. This action created artificially high embankments forcing a change in river currents and streambed configuration.

*Photo taken during the summer. Note how far the angled section of the crib has slumped down into the water. The large hemlock tree in the background had listed before the crib was constructed, but with the slump it looks even more precarious.*

The result was the undoing of a lot of previous hard work. The inmates ripped off the welded wire from the crib and lifted out the stone, rock by rock. Logs on the top tier were sawn and pried out. The same procedure began on the bottom tier, except the logs were kept in place. Once the weight of the stone was removed, three large logs were chained together as a tripod, and a hand "come-along" allowed the inmates to vertically winch up sections of the slumped crib. Hemlock planks were set down on the empty crib so huge stones could be rolled

With the bottom tier once again at the correct level, and with enormous stones hindering the escape of smaller stone placed behind them in the crib, refilling of the crib commenced. Then the placement of welded wire and the rebuilding—from scratch—of the crib's top tier. A finishing touch of insurance was the spiking of hemlock planks onto the face of the bottom tier. Planks were placed as far into the streambed as possible to make additional undermining more difficult.
